How NIST Avoided a Real Analysis of the Physical Evidence of WTC Steel

Andrea Dreger

(I) NIST's exclusion of most of the recovered structural steel from being adequately examined for their damage and failure modes

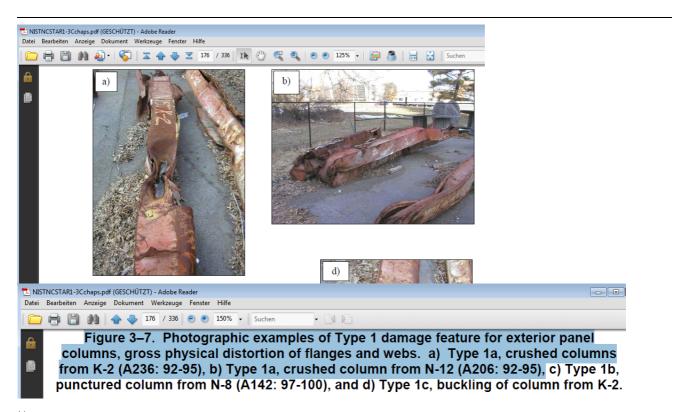
but the "crushed column" from panel K-1 (see photograph below, paragraph "Perimeter Panel K-1"), the failure mode of which is described as "crushed" by NIST too, has a completely different quality of "crushed."¹⁴

¹⁴ See NIST NCSTAR 1-3C, page 219 (PDF-page 269) for NIST's description of K-1

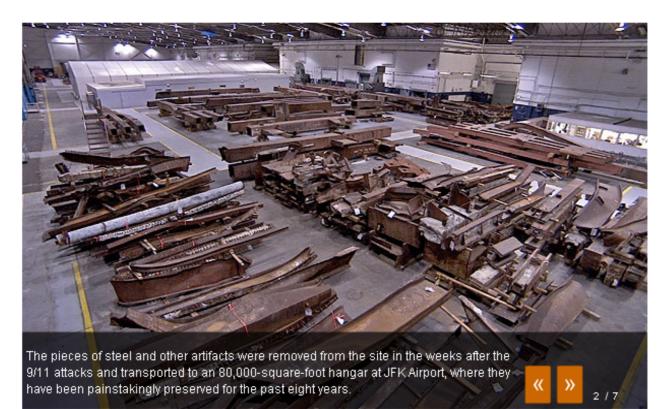
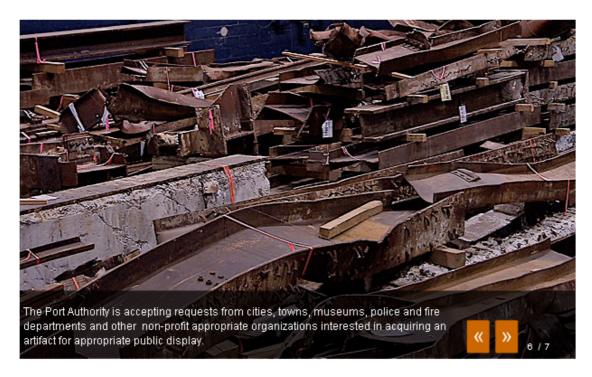
Photographs from http://www.panynj.gov/wtcprogress/wtc-9-11-steel.html

evidentiary justification is given why NIST's personnel "considered" the bulk of the steel as not important. The photographs below show recovered WTC steel, held in hangar 17 at JFK airport. All the steel pieces on these photographs, except the 6 pieces from which NIST had portions removed, were not "catalogued" by NIST²¹ and were thus de facto excluded from NIST's WTC investigation.

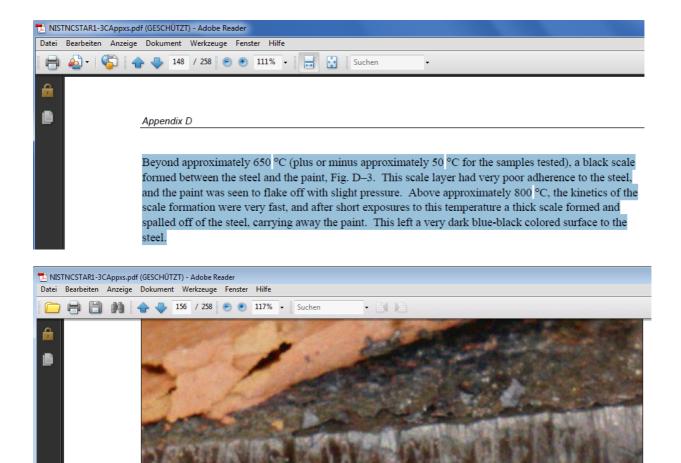
Source: NIST. Figure D–4. Formation of a black scale between paint and steel after exposure greater than 650 °C. Paint readily spalled.

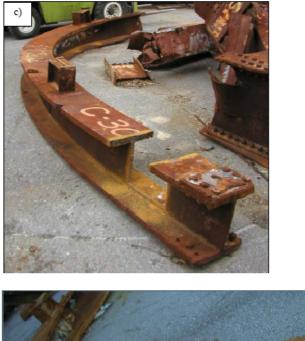
Another example of the effect of NIST's exclusionary tactics and of the poor quality of NIST's investigation is NIST's failure to adequately examine core column C-30.⁴⁵ The as-built location of C-30 was in WTC 2, stories 104 to 106⁴⁶ at the north-east corner of the core. The column displays obvious signs indicating that it was bent at high temperatures and while it was still restrained in a frame. C-30 shows for most of its length a smooth bend without cracks and without buckling of the flanges, indicating that the smoothly bent part was at high temperatures when it was bent. In addition, the column is bent only along one axis; the flanges are still in one plane,⁴⁷ indicating that the column was still well restrained in the frame when it was bent. See photographs from NIST NCSTAR 1-3B (page 44) and NIST NCSTAR 1-3D (page 258) that show C-30.

Since it is indicated that the deformation of column C-30 happened at high temperatures and while the column was still in the building, and since the indications are so obvious to notice when the common method of unaided visual examination is employed, it would have been NIST's duty to follow up on the possibility of a high temperature exposure of column C-30 while it was still in the building. But C-30 was located far above the fire areas; following up on these indications had the potential of falsifying NIST's premise. If further examinations would have supported what is indicated by the deformation and characteristics of C-30, NIST would have documented data that prove that a fireproofed core column was exposed to very high temperatures outside of the fire areas. Both the circular argument described above (which excluded C-30 from any examination regarding its damage and

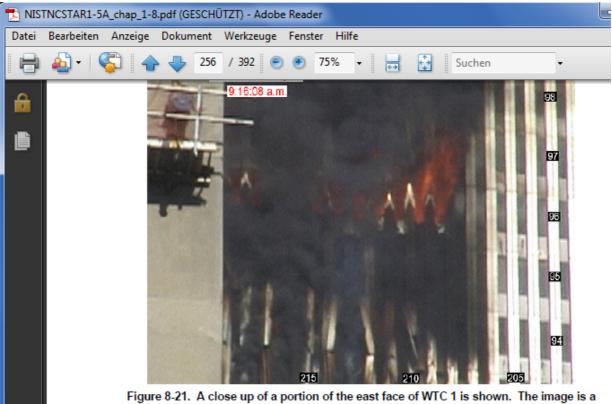
Figure 8-21. A close up of a portion of the east face of WTC 1 is shown. The image is a frame taken from a video recorded at 9:16:08 a.m. Column and floor numbers have been added. The area to the left with the scaffolding is another building in the foreground.

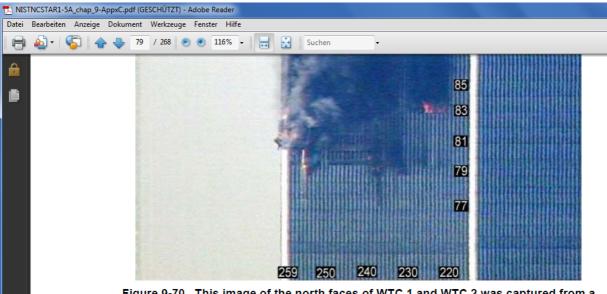
Figure 9-70. This image of the north faces of WTC 1 and WTC 2 was captured from a video recorded at 9:51:54 a.m. The intensity levels have been adjusted, and column and floor numbers have been added to WTC 2.

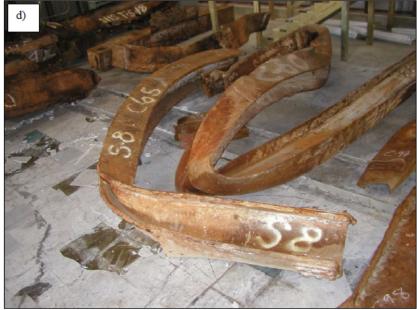
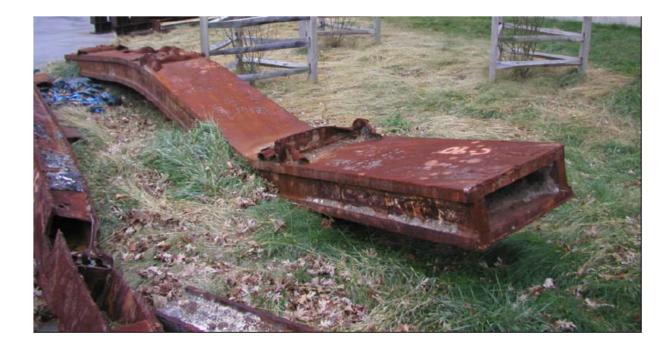
Source: NIST.

⁷⁰ C-60 and C-65: photograph from NIST NCSTAR 1-3B, page 40 (PDF-page 68). C-60, an unidentified column (NIST NCSTAR 1-3B, page 10, PDF-page 38) is to the right hand side in the photograph, C-65 is to the left hand side. C-90: photograph (cropped) from NIST NCSTAR 1-3B, page 44 (PDF page 72). For a photograph of C-71, see above, page 22.

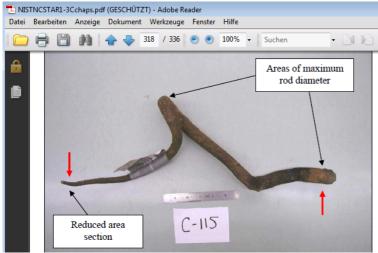
⁷⁶ There is no paint left on the truss rods, and the paint used for the trusses was also not validated by NIST for a possible mud-cracking effect. See photograph/screenshot from NIST NCSTAR 1-3C that shows one of the truss rods.
