BEYOND MISINFORMATION

What Science Says About the Destruction of
World Trade Center Buildings 1, 2, and 7

© 2015 Architects & Engineers for 9/11 Truth, Inc.

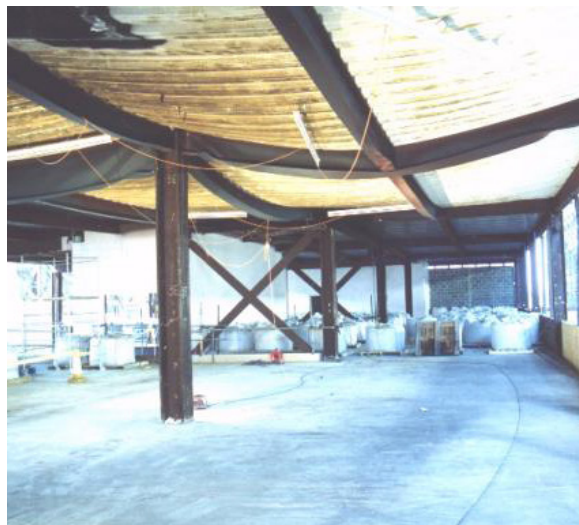
BRE tests in Cardington, United Kingdom.

The NIST survey also noted two major fire test programs conducted at the Building Research Establishment (BRE) Laboratories in Cardington, United Kingdom. The first series of tests, conducted on a representative eight-story composite steel-framed office building, resulted in significant fire damage but did not result in collapse, even with unprotected steel floors. The second series of tests conducted on a seven-story concrete building also did not result in collapse.

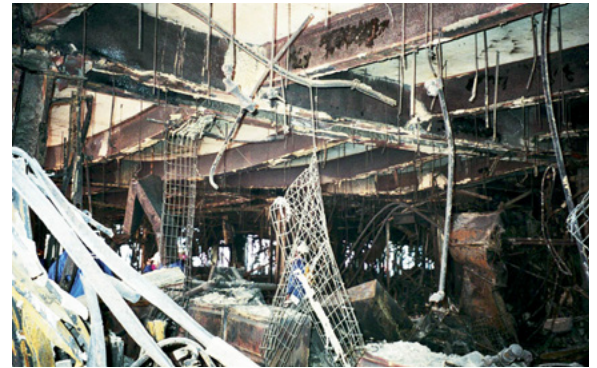
Fire damage in WTC 5 (2002 NIST survey of fires that resulted in total or partial collapse).

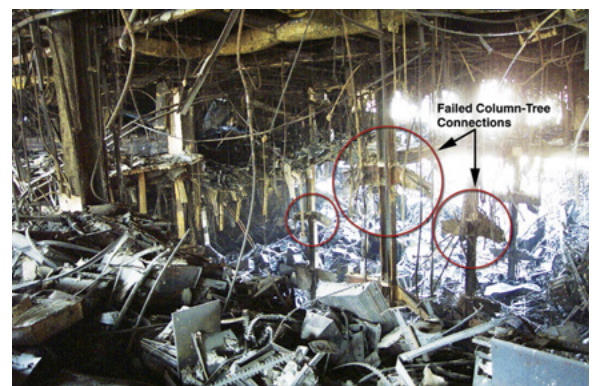
Partial connection and floor failures in WTC 5 (2002 NIST survey of fires that resulted in total or partial collapse).

- **One New York Plaza** experienced local connection failures resulting in filler beams dropping onto their supporting girders on two floors.
- **Alexis Nihon Plaza** experienced a partial collapse of its 11th floor, which was arrested by the floor below it.
- **WTC 5** experienced partial collapses of four floors and two bays.

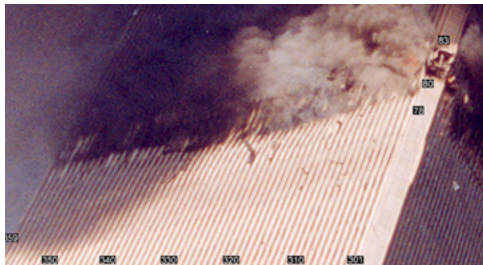
WTC 2 exterior columns bowing inward across the east face between Floors 77 and 83 at 9:58:55 a.m. (NIST NCSTAR 1-6, page 178, Figure 6-21).

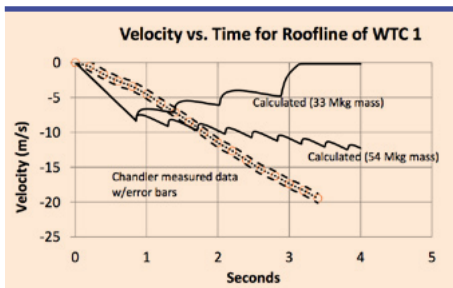
In this graph from Szamboti and Johns' Discussion paper, the observed velocity of the roofline of WTC 1 is compared with the velocity calculated using Bazant and Le's analytical method, but with corrected input values, showing significant decelerations at each floor.¹¹

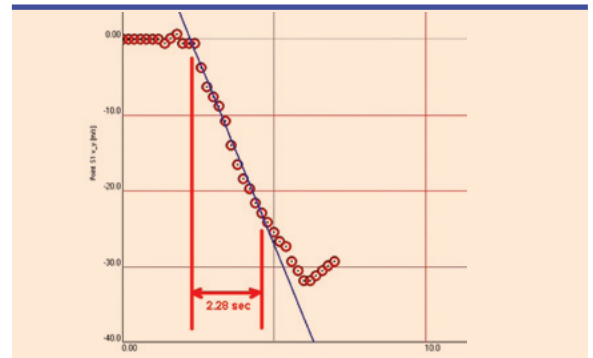
David Chandler's graph from Part 3 of "NIST Finally Admits Free Fall" plots the velocity of WTC 7's roofline versus time. The slope shows a free-fall rate of acceleration. The sudden change in slope shows the sudden onset of free fall.

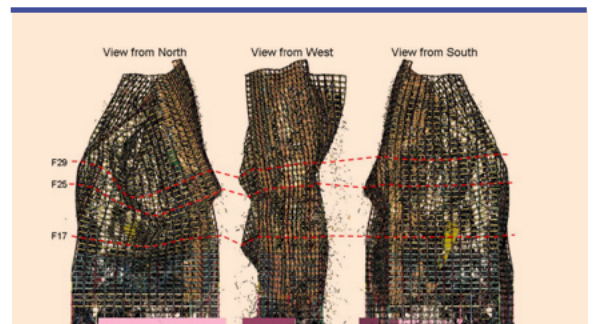
NIST's model of WTC 7's collapse shows large deformations to the exterior of WTC 7 not observed in the videos, while failing to show 2.25 seconds of free fall.

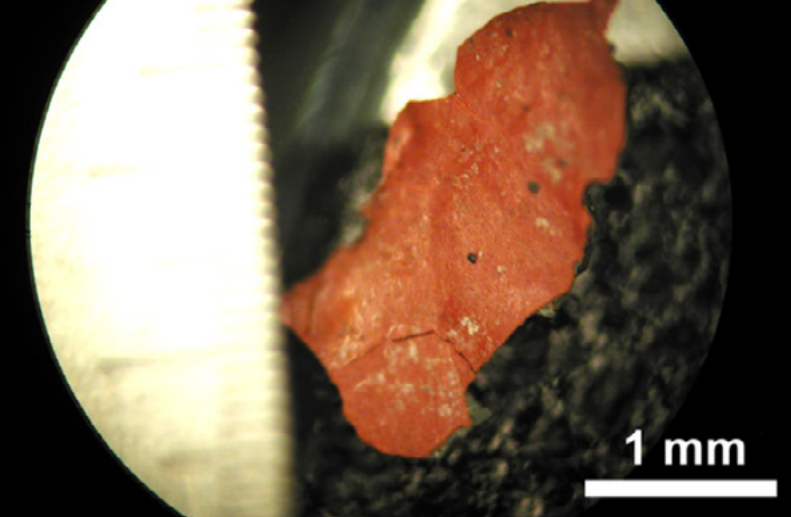
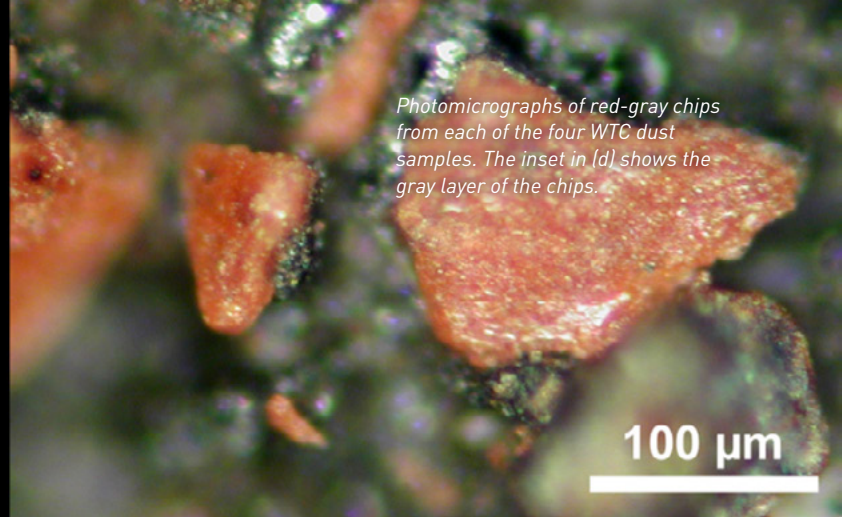
Photomicrographs of red-gray chips from each of the four WTC dust samples. The inset in [d] shows the gray layer of the chips.

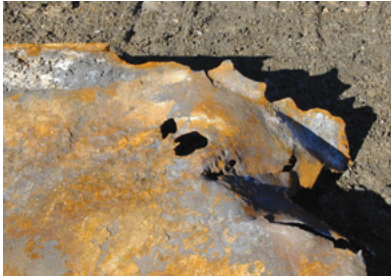
The eroded, sulfidated steel from WTC 7 at the scrapyard before it was cut off and taken for testing.

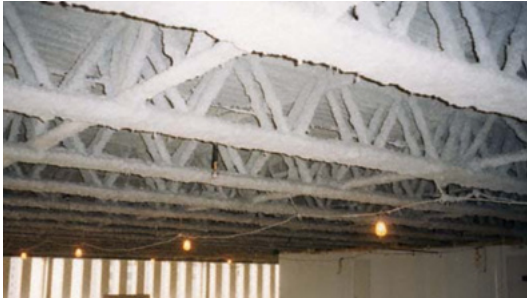
A photograph of WTC trusses with fireproofing.
