How NIST Avoided a Real Analysis of the Physical Evidence of WTC Steel

Andrea Dreger

(I) NIST's exclusion of most of the recovered structural steel from being adequately examined for their damage and failure modes

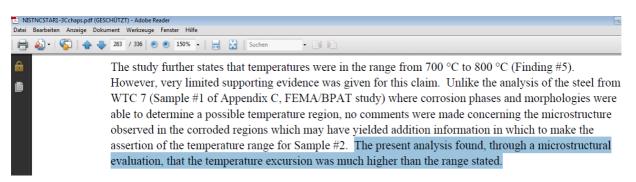
The Appendix C sample (2), a heavily corroded perimeter column, was examined by NIST (referred to by NIST as K-16), with the result that NIST concluded that it must have been exposed to even "much higher temperatures" than the 700 to 800°C assumed in Appendix C.⁷⁹ See quote/screenshot from NIST NCSTAR 1-3C, blue highlight added.

By this NIST acknowledges that a piece with an as-built location far below the impact and fire area must have been at temperatures that were much higher⁸⁰ than the range of 700 to 800°C, either while it was still part of the building, or after the destruction.

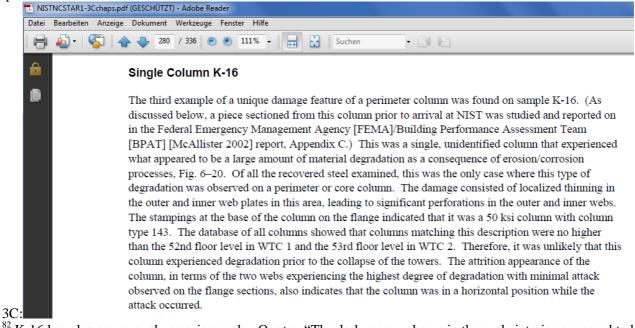
⁸¹ NIST states that the possibility that the steel was exposed to the high temperatures while part of a building was "unlikely." This "unlikely" but not ruled out option is not further discussed by NIST. NIST assumes that the steel was corroded while it was in the piles because of the fact that areas of the two web-plates of the column were corroded heavily by a high temperature attack, while the flanges of the column in the same area were not much affected, concluding that the piece must have been in a horizontal position during the corrosion process. See quote/screenshot from NIST NCSTAR 1-

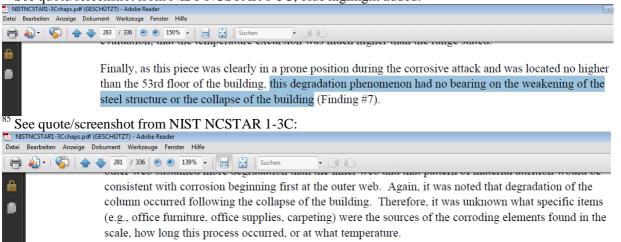
building")⁸⁴ and distracts from the relevant problem that K-16 proves the use of heat sources other than mere fires (either in the building or in the pile) with the statement that it was "unknown at what temperature" the corrosion process occurred.⁸⁵ But by determining that the process happened at temperatures well above the range stated in FEMA's Appendix C, NIST provides relevant data regarding the temperatures at which the corrosion process occurred, namely data that show that the corrosion process occurred at temperatures that are much higher than those that fires in dust covered and oxygen starved "collapse piles" can possible produce.⁸⁶ By not addressing or discussing this problem, NIST implicitly declares the "incident scene" as not relevant for its investigation of the "incident."⁸⁷ But all available data – including all data from the incident scene,⁸⁸ – are supposed to be collected and discussed, a fact which is certainly known by NIST, which cooperates closely with the NFPA,

⁸⁴ See quote/screenshot from NIST NCSTAR 1-3C, blue highlight added.
